Non-Destructive Measurement Methods (Neutron-, X-ray Radiography, Vibration Diagnostics and Ultrasound) in the Inspection of Helicopter Rotor Blades

M. Balaskó¹, G. Endrőczy², Gy. Tarnai³, I. Veres⁴, Gy. Molnár⁴, E. Sváb⁵

¹KFKI Atomic Energy Res. Inst. H-1525 Budapest, POB. 49.

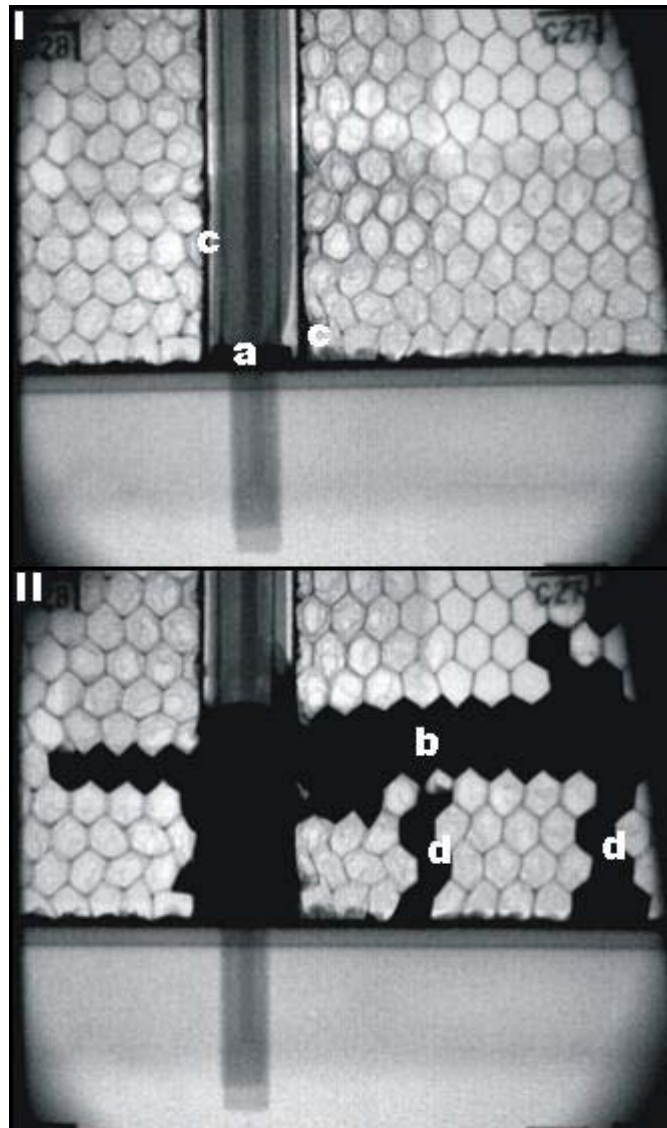
Plenty of moisture was found inside the rotor blades. The moisture was characterized depending on its origin. The first category was where the water was identified in the dry state. The second one was where the water was found after the moistening procedure between the different sections. The third one was where the water was found after the moistening procedure inside of the sections behind of the fiber-glass/epoxy honeycomb structure. Fig. 9. shows the NR picture of the C27 picture field in dry (Fig. 9/a) and in wet (Fig. 9/b) state.

Figure 9/a: The NR picture of C27 exposed picture field in dry state (up).
Figure 9/b: The NR picture of C27 exposed picture field after the moistening procedure (down),
- a= support gum, b=horizontal by-pass, c= borders of the sector, d= vertical by-pass.

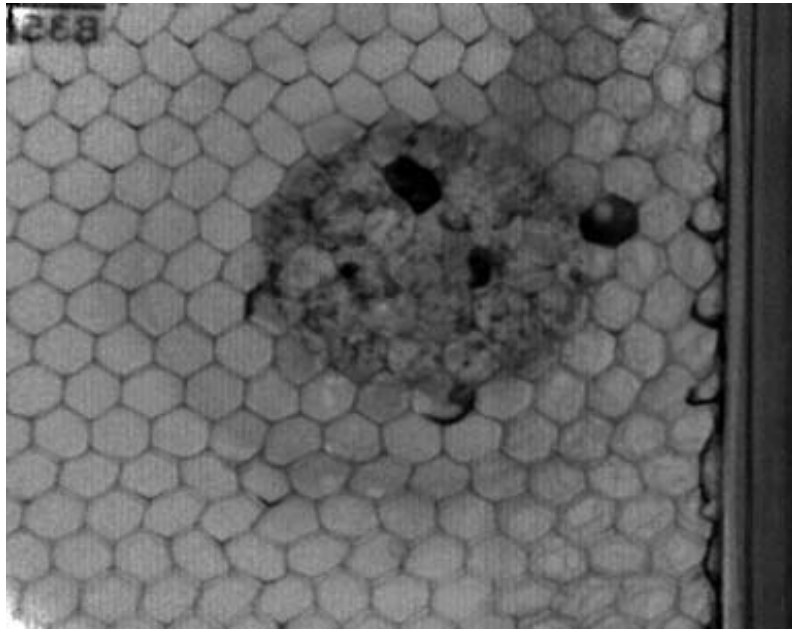
In this respect to monitor the result of the reparation in service seems to be prerequisite. Fig. 10 shows the repaired area of the honeycomb structure of the B35 exposed picture field. It is clear that the reparation surface and its inner structure can only be investigated by NR (Fig. 10/a), while that of metal inclusion by XR in Fig. 10/b. The whole repaired area, as determined by NR imaging, was measured to be 27770 mm².

Figure 10/a: The NR picture B35 exposed picture field with the reparation area. The resin rich areas give darker contrast.

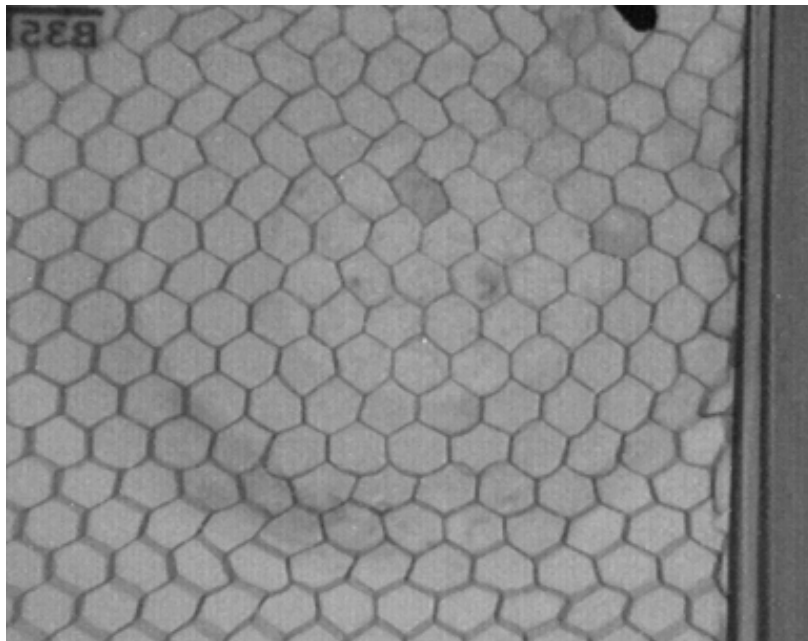
Figure10/b: XR picture B35 exposed picture field with the reparation area. The resin rich area hardly see but the metal inclusion is visible on the right-up corner.

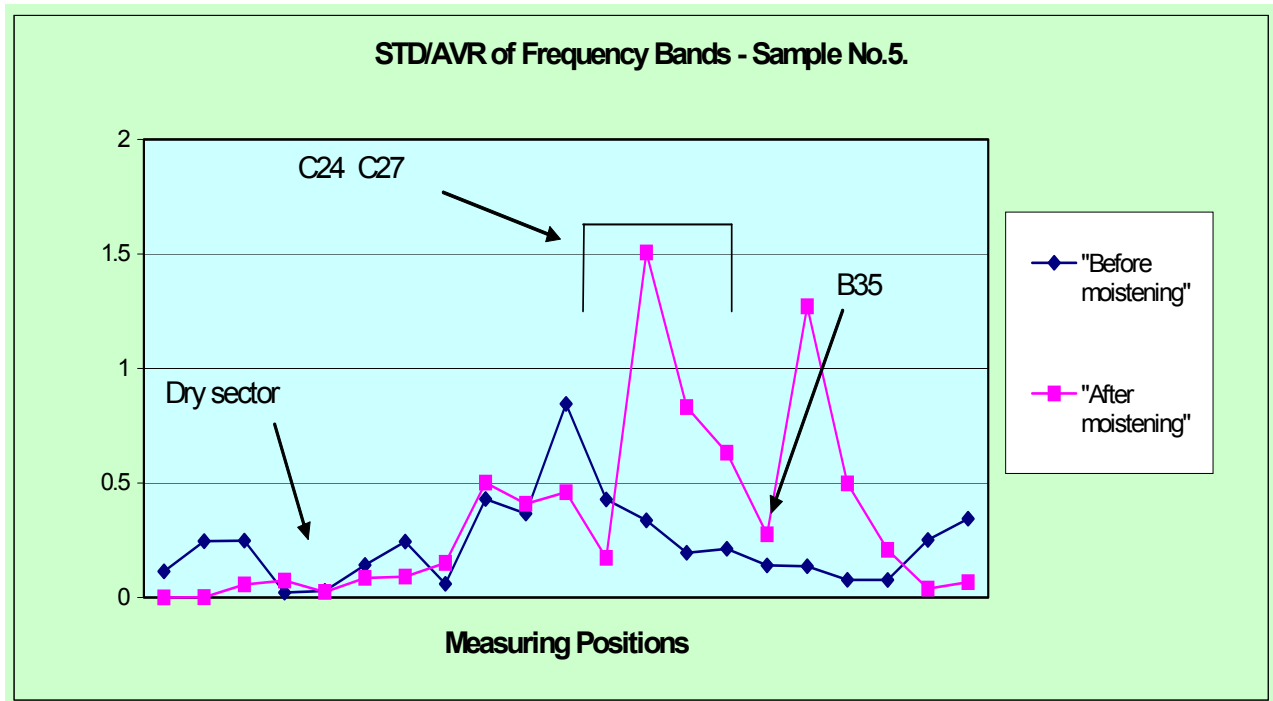
depending on the position of rotor blade. The STD is the standard deviation and the AVR is the average. The VD measurement is able to detect the rough errors in the rotor blade. Both the water percolation (C27) and place of the reparation (B35) are distinguishable.

Figure 11: The STD/AVR of frequency band depending on the position of the rotor blade.

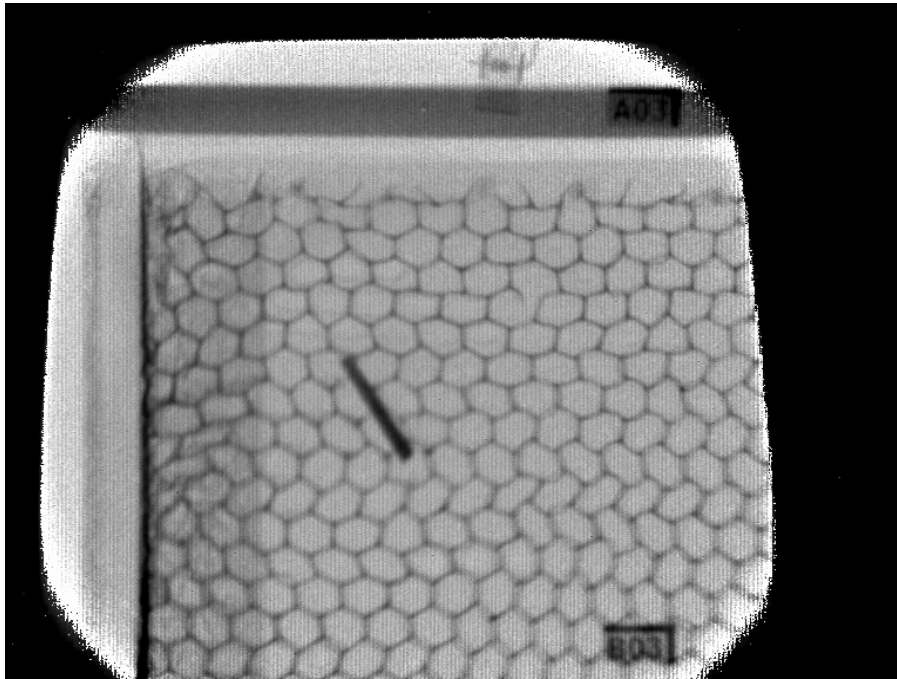
Figure12: NR picture of the A03 exposed picture field on the Reference-2 object with a metal inclusion in the middle of the field.

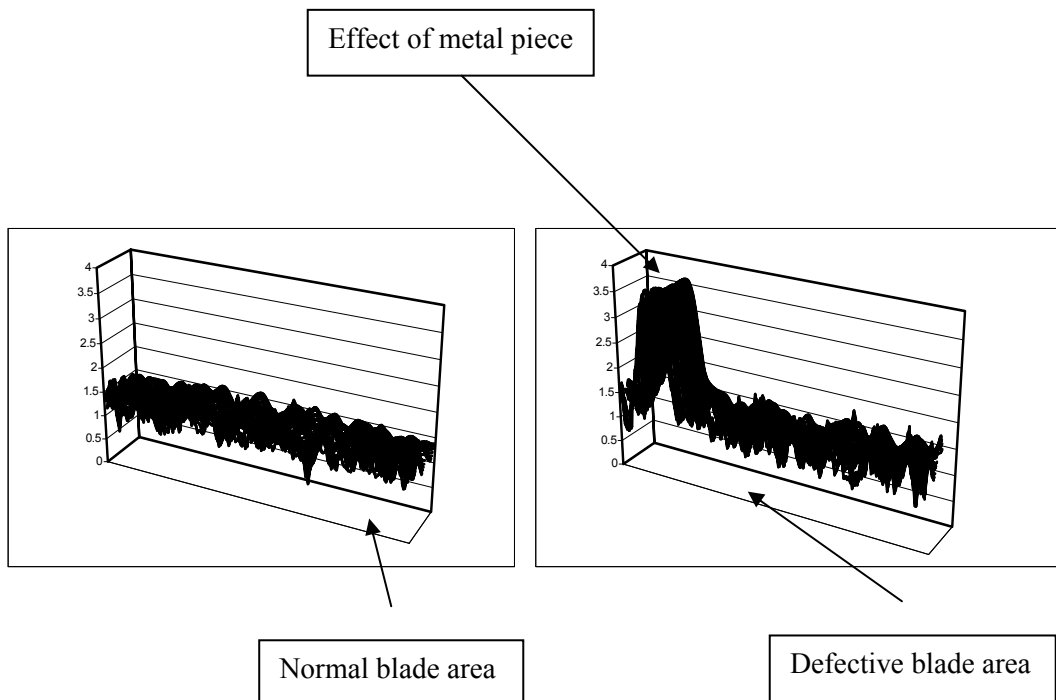
During the experiments of the defected Reference-2 object was scanned and analyzed in different frequency bands. Fig.13. shows the scanned vibration pattern of a defective blade part around 80kHz. The picture demonstrates that the small metal piece integrated in blade changes the local acoustical stiffness of the blade.

Figure13: Scanned acoustical pattern of metal piece defected blade.

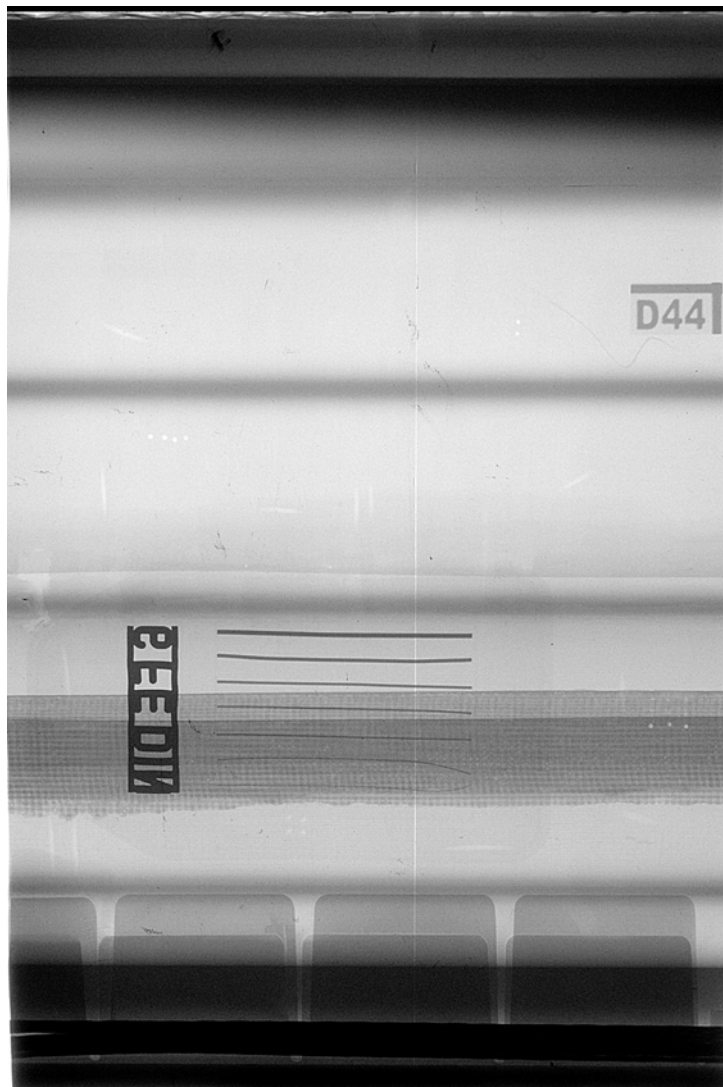
For the UT measurements a special object was produced (see Fig. 6.). Its XR picture (40 kV;2,5 mA) is shown in the Fig.14. It contains of some holes (diameter is 0,4mm) and some crack imitation (0,4 X 10 mm²) in the material of aluminum alloy spa with the 6FE type wire picture quality indicator on the D44 exposed picture field. In the tests to detect the cracks of main spar's section we used the principle of ultrasonic physics that the significant part of energy, using the appropriate inspection technology, rebounds in echo form from the cracks. The test would be successful when the echoes descending from the cracks simulation in sections, clearly, are detected and can be located.

Figure 14: XR picture of the special object (D44 exposed picture field) for UT measurement contains of holes and imitation of cracks with 6FE type picture quality indicator.

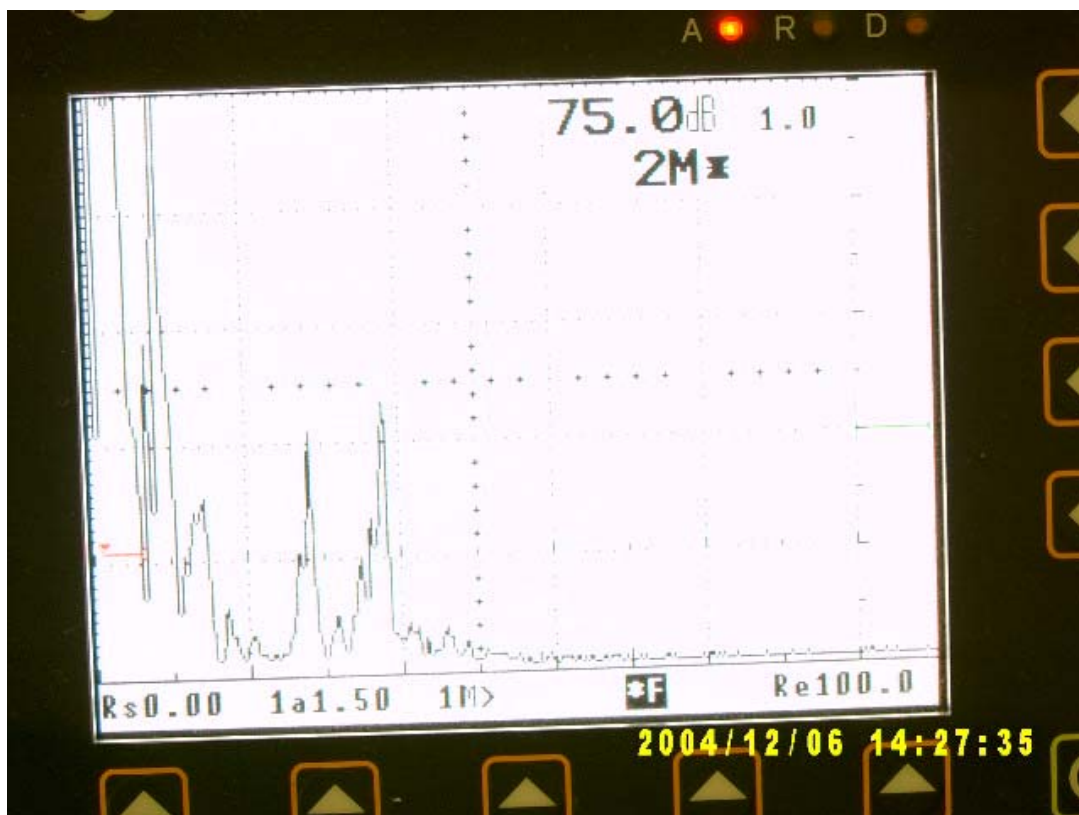
In the course of tests we guided the inspection head all along on the outside surface of the main spar twice. In first case the direction of radiation was perpendicular to the frames, in second case it was parallel with frames. The equipment was calibrated to soundway-distance. The geometrical calibration of inspection unit (equipment, cable and probe), the measuring range was configured 0-100 mm. The inspection/testing amplification was 80 dB. In the case of detected „cracks” with probe approaching to notches from perpendicular direction, we grew the echo, which is proportional to the reflected ultrasonic energy, to the maximum. To recording A-picture, with the individual proportion, we decreased the volume of amplification. In the course of scanning all defects were detected successfully. In the following, we show A-pictures typical from point of view of inspection, through that the possibilities and limits of the method are interpreted well. On the Fig. 15 is shown A-picture of inspection, which is placed near the edge of main spar. On the figure three signals can be differentiated: main bang (left side), echo from the insection (middle) and the signal of energy rebounded (right side) from the edge of main spar (the first reflection rebounds from the crack [middle pick], the second from the edge of main spar [right pick]).

Figure 15: A-picture of insection, which is placed perpendicular to the frame, on the outside surface and near the edge of main spar.

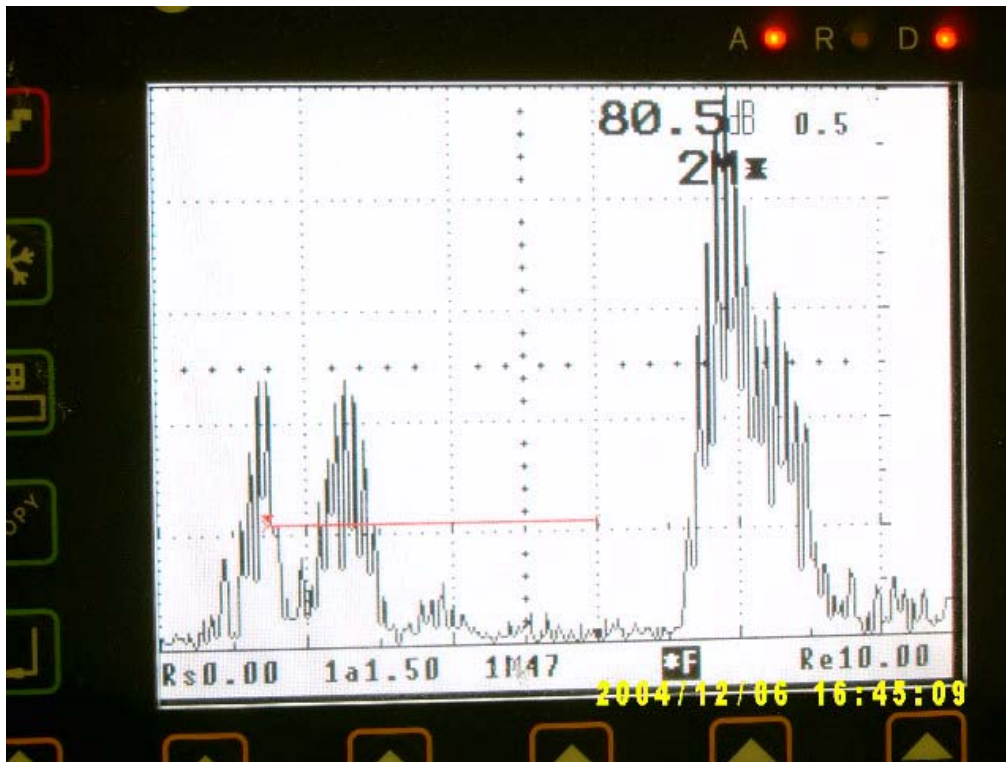
Figure 16: Bond test, Picture of A with application of inspection probe type DA 312.

On the Fig. 16 this A-picture, which we received from ultrasonic test of an unknown quality joint. On this Figure two signal groups can be seen. The signal group A (left side) shows the range of the received reflection from surface of the joint view of cover-plate. The A signal group, practically, is approaching the echo scale that experienced by the measures of wall thickness. The B signal group (right side), means the radiant ultrasonic energy rebounding through the cover-plate, the adhesive bonding and the main spar.
